Date of Issue: 23 September 2015

SMRT to be Penalised \$5.4 million for 7 July Incident

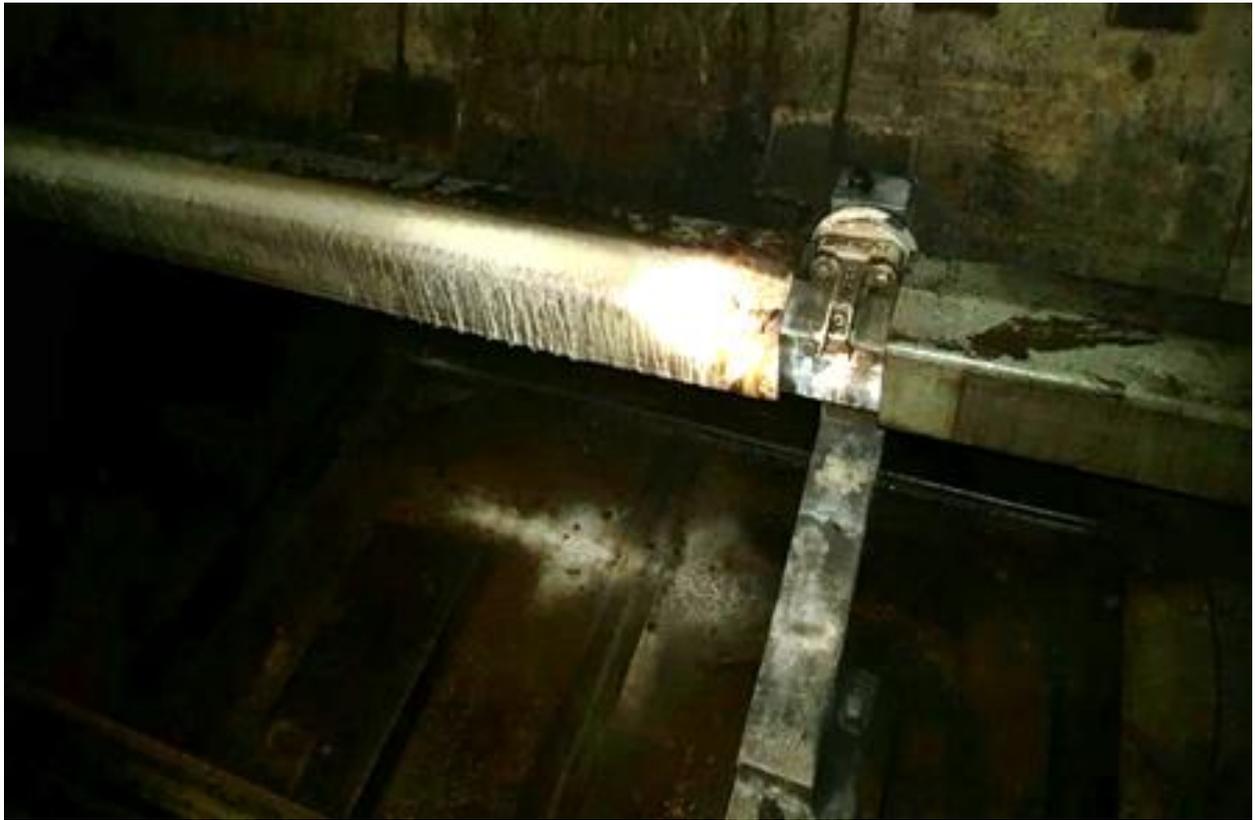
2. As announced during the media briefing on 29 July 2015, the disruption was caused by intermittent tripping of the rail power system at multiple locations by the 64P¹ safety mechanism. A combination of factors had resulted in weak electrical resistance of one of the third rail insulators between Tanjong Pagar and Raffles Place MRT stations, which in turn activated the 64P mechanism.

3. Supported by specialists from Parsons Brinckerhoff and Meidensha Corporation², LTA identified an ongoing water leak in the tunnel close to the insulator as a contributor to the weak electrical resistance. The leak, and inadequate maintenance, had resulted in extensive mineral deposits on the insulator and trackside equipment. Laboratory tests found high chloride content in samples of the water seepage and in the deposits. The consultants deduced that the conductive mineral deposits, together with the wet tunnel environment, had significantly reduced the effectiveness of the insulator.

4. As a result, electricity flowed from the insulator to the ground, resulting in a higher than normal voltage between the running rail and the ground. This abnormal voltage, coupled with the usual voltage fluctuation as trains move, activated the 64P safety mechanism and tripped the power system. LTA's findings are corroborated by the fact that the intermittent tripping stopped after SMRT had replaced the contaminated insulator and rectified the tunnel water seepage.

Figure: Tunnel water leak onto third rail at Tanjong Pagar - Raffles Place tunnel

5. LTA has concluded that the incident could have been prevented if SMRT had rectified the tunnel water seepage as required under LTA's Code of Practice for maintenance. Under the Code, SMRT has to attend to any tunnel water dripping directly on trackside equipment, such as the third rail, immediately upon discovery. If grouting works cannot be carried out, the operator has to divert the water seepage away from the trackside equipment. Based on SMRT's records, they had detected seepage in the tunnel section in question on its routine track patrols in mid-June 2015. However, these leaks were attended to only in end-July. The extent of mineral deposits on the trackside equipment also shows that SMRT's maintenance measures had been inadequate.

10. LTA has asked SMRT to provide a detailed response and rectification programme to address the findings. To prevent a similar recurrence, SMRT has started replacing all third rail insulators since the incident, starting with insulators which have shown signs of electrical resistance weakness.
