What caused the cracks

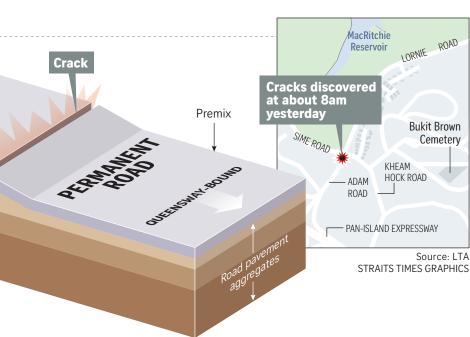
WATER PRESSURE

Steel plate —

High-density – extruded polystyrene

• Water had accumulated at the roadside due to the heavy rain and seeped under the road base. The built-up water pressure caused the temporary section of the road to heave, resulting in the cracks on the road surface.
