What happened to Flight QZ8501

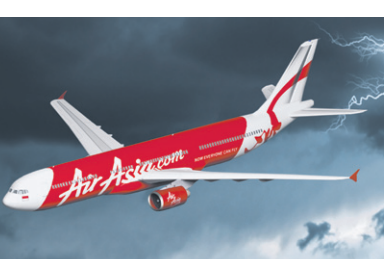
The Airbus A320-200 had a faulty component – the Rudder Travel Limiter (RTL) which helps control the plane's rudder movement, limiting how much it can roll to no more than 33 degrees. Here's what happened about 25 minutes after the plane took off from Surabaya.

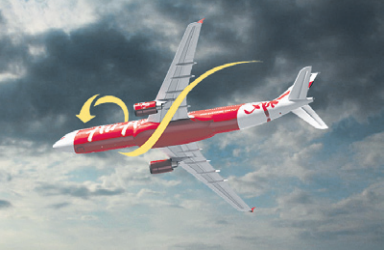
- The RTL sends four “master cautions” or warning indicators to the pilots.
- The crew resolves the issue the first three times but on the fourth, the pilots try to reset the RTL system.
- One or both pilots apparently removes and re-inserts circuit breakers to the flight computers.
- This leads to a power cut and the autopilot turns off.

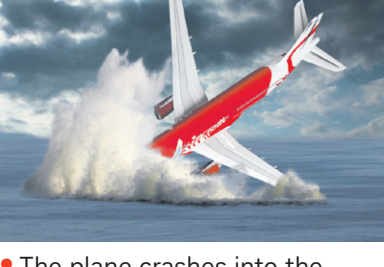
- The rudder turns 2 degrees left, sending the aircraft into a 54 degree roll.
- The pilots try desperately to regain control of the aircraft.
- The plane's black box indicates possible confusion between the pilot and co-pilot. At one point the pilot says “pull down,” but the plane continued to ascend.
- The crew never regains control of the aircraft which goes into a “prolonged stall”.

- The plane crashes into the Java Sea.
