MRT tunnel flooding: How it happened

A failure to properly maintain a storm water reservoir resulted in rainwater overflowing and flooding the tunnel between Bishan and Braddell MRT stations, causing services on a section of the North-South Line to be inoperable for 20 hours on Oct 7 and Oct 8.

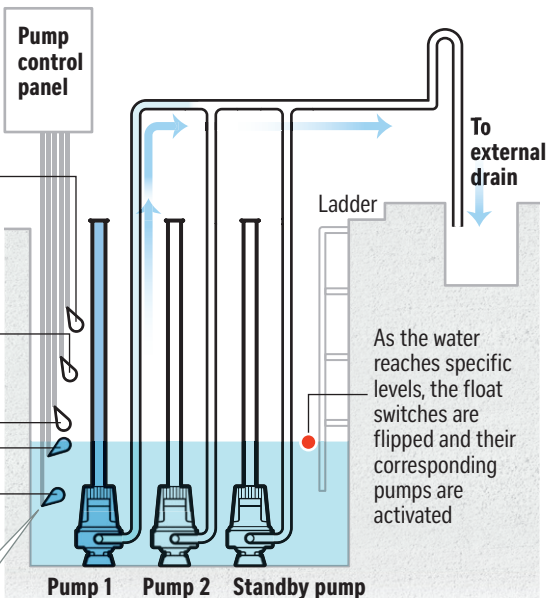
High water level switch

Sends an alarm to SMRT's Operation Command Centre (OCC) when submerged.

All-stop float switch

- When the water level is at its lowest, it keeps all the other switches on "pause".
- It acts as a safety feature to prevent the pumps from dry running, which can lead to overheating and damage.

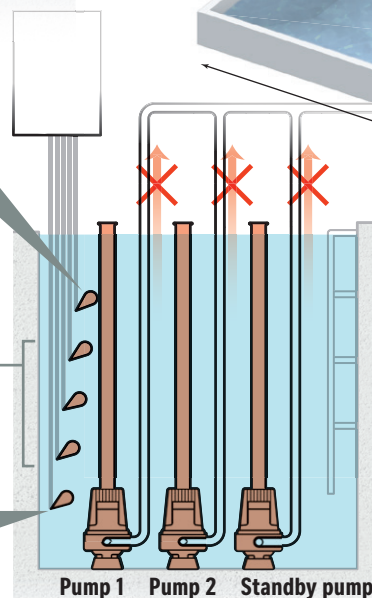
FAULTS DISCOVERED

High water level switch was found to be faulty, failing to send an alarm to OCC when the water level became critical.

Pump float switches remained on "pause" and failed to activate the pumps.

Faulty all-stop switch kept all the other pump switches on "pause".

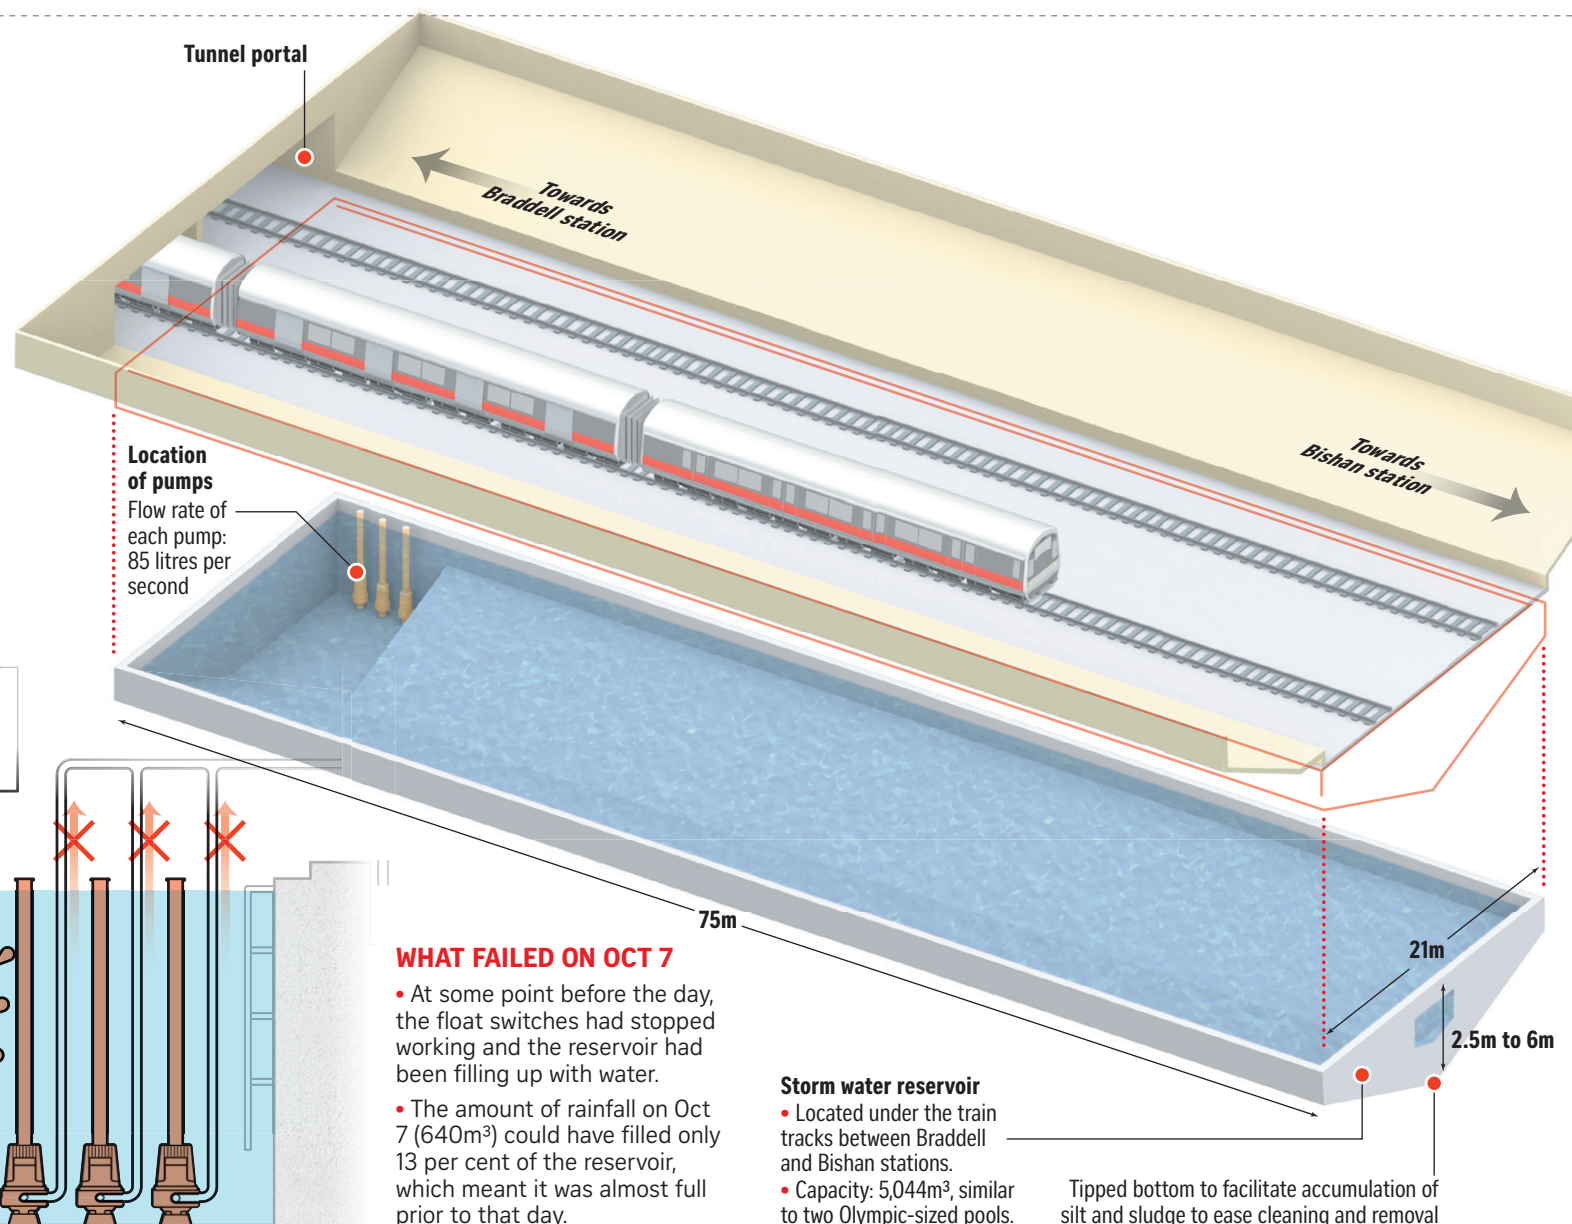
Pump 1 Pump 2 Standby pump

WHAT FAILED ON OCT 7

- At some point before the day, the float switches had stopped working and the reservoir had been filling up with water.
- The amount of rainfall on Oct 7 (640m³) could have filled only 13 per cent of the reservoir, which meant it was almost full prior to that day.
