# Three possible reasons for failure of anti-flooding system

Investigations by the Land Transport Authority could not definitively establish what led to the Oct 7 flooding incident, though the LTA said it was down to "a lack of proper maintenance, supervision and audits".

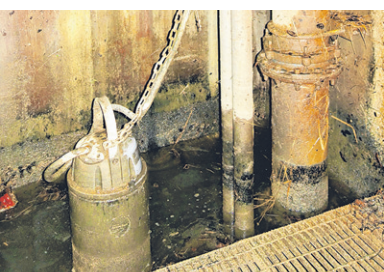
**1** The lowest float switch, which would have activated the storm water sump pumps, was impeded by accumulated silt and sludge in the Bishan storm water sump pit.

- 1** All existing float switches at Bishan storm water sump pump pit replaced by SMRT
- 2** LTA replaced Bishan pumps with heavier-duty ones capable of handling water with sediment
- 3** New radar-based sensor system added to monitor water levels in the pit
- 4** New sump pump control panel installed, located away from tracks to facilitate access during passenger service hours
- 5** Accumulated sludge, silt and debris removed from pit. All non-serviceable pumps on the North-South and East-West lines replaced, with float switches replaced as a precaution

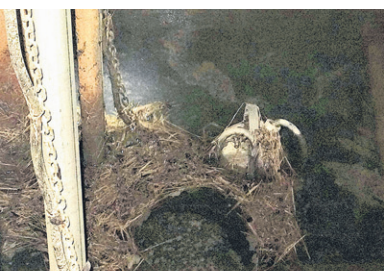
**2** Floating debris in the pit could have impeded the normal functioning of the float switches, in particular the highest float switch, which alerts SMRT's Operations Control Centre to high water levels.
