# What could have happened

In the final investigation report, an authorised examiner reconstructs how the doors of a lift at Block 322, Tah Ching Road, might have severed the hand of Madam Khoo Bee Hua

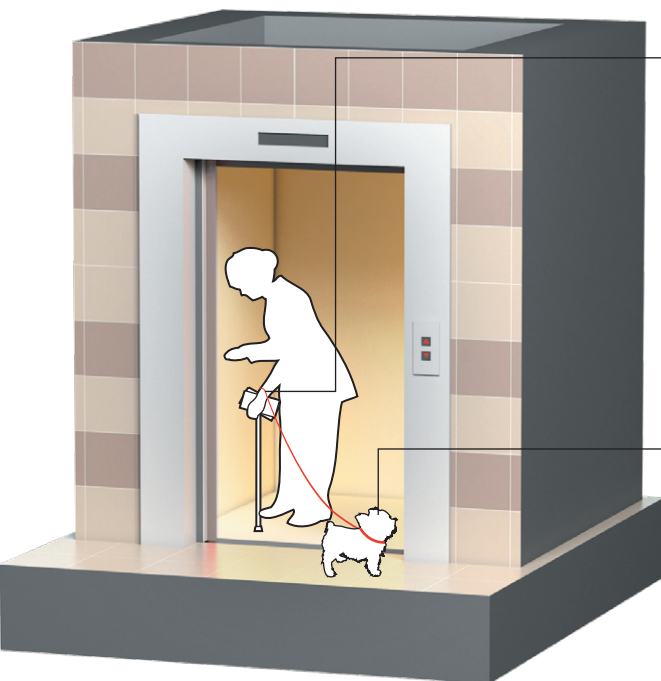
- 1 • She presses the button for the 16th floor with her right hand, and then the "Close" button.
  - The leash for her dog is looped around the 85-year-old's left wrist.
- 2 • Her dog is still outside as this happens.

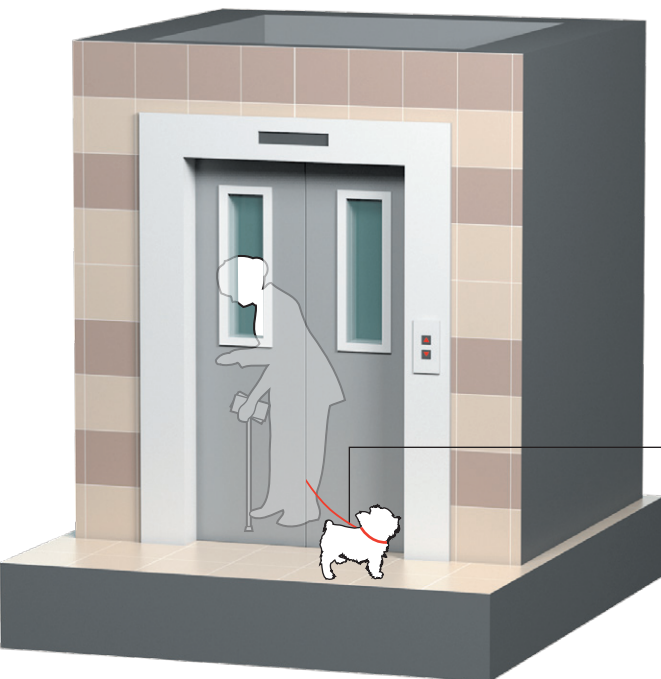
- 3 • The 2mm-thick leash is too narrow to activate lift sensors that would have reopened the doors.
  - Instead it is caught in between.

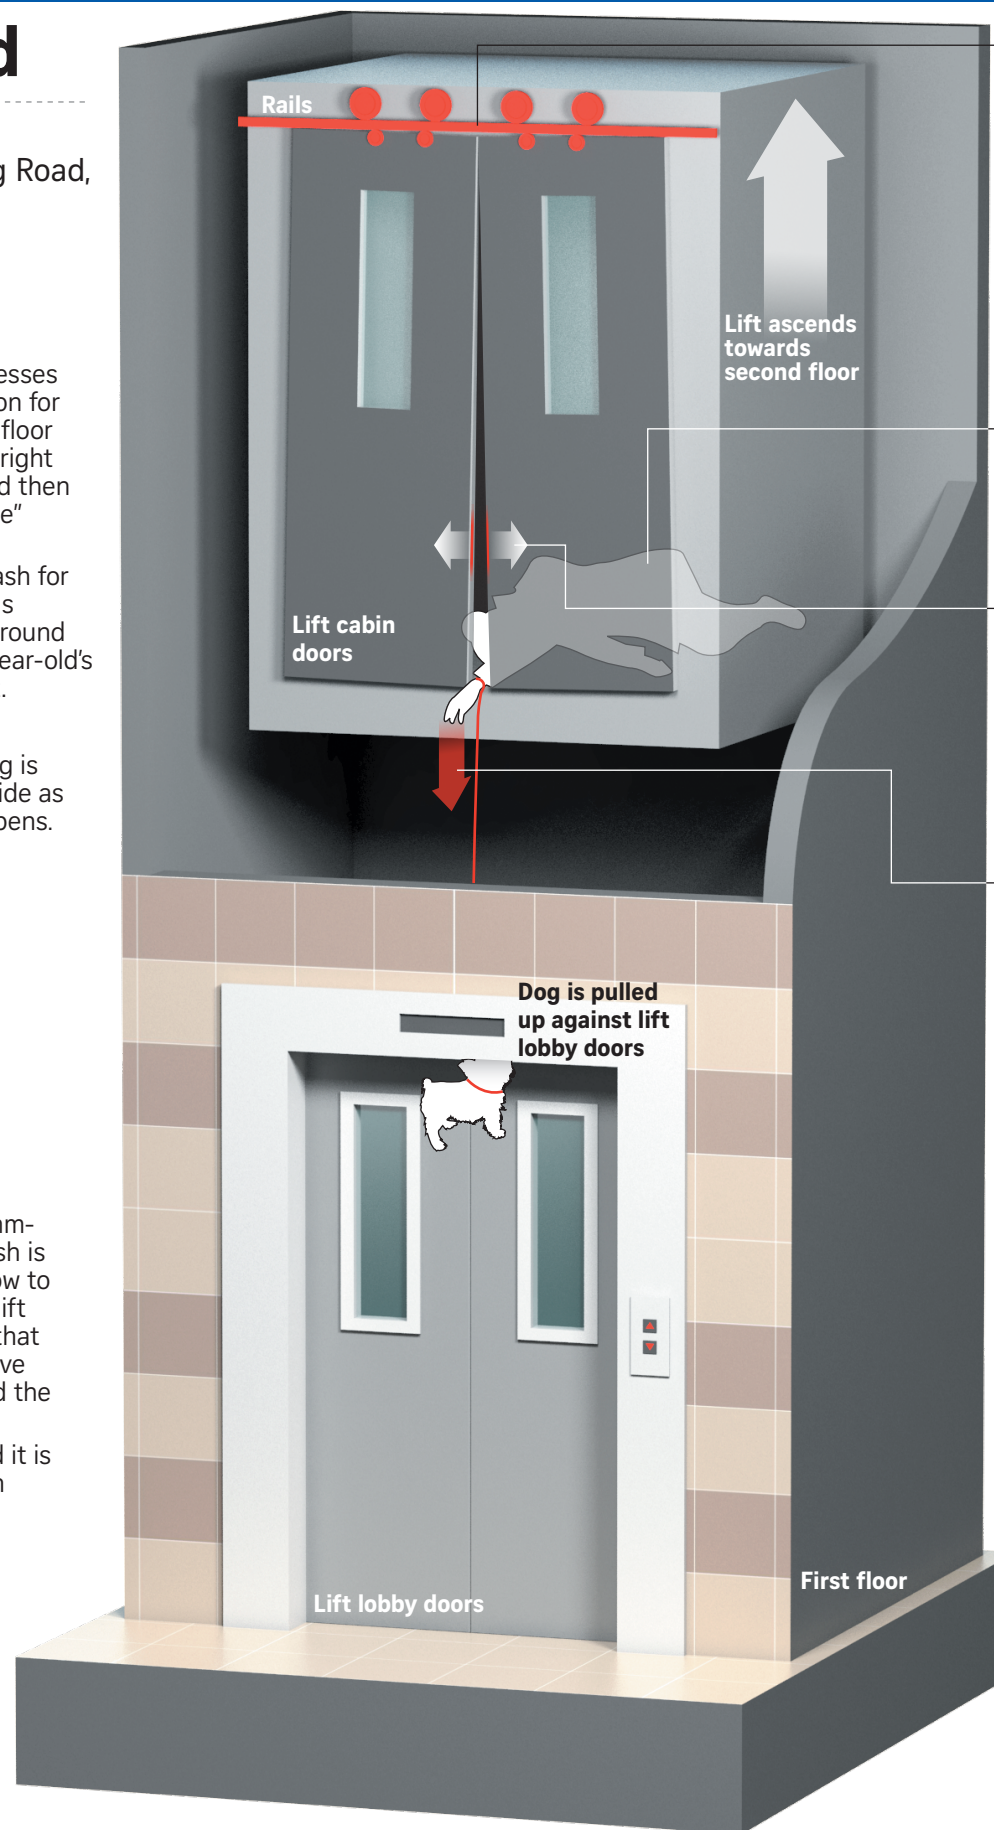
- The lift cabin doors are hung from rails at the top.
- If a significant force is applied to the bottom of the lift cabin doors while they are closed, it is possible for the doors to be prised open slightly.
- The gap would be narrowest at the top and widest at the bottom, forming a slim A-shape opening.

- 4 • As the lift rises, the leash around Madam Khoo's wrist tightens. She is pulled to the floor. The dog is also pulled up against the lift lobby doors till its harness buckle is caught at the top part of the lift lobby door.
- 5 • The pull of the taut leash against the lift doors forces them apart slightly, opening up a small gap at the base.
  - As the lift continues to go up, the force of the leash is strong enough to pull Madam Khoo's left hand through this small gap.
  - The hand widens the gap, triggering the lift to come to a gradual emergency stop.
- 6 • The hand is crushed and severed between the lift cabin doors and the internal parts of the lift lobby doors. This happens near the second floor landing.
  - The lift stops near the third floor. The severed hand falls to the bottom of the lift pit.

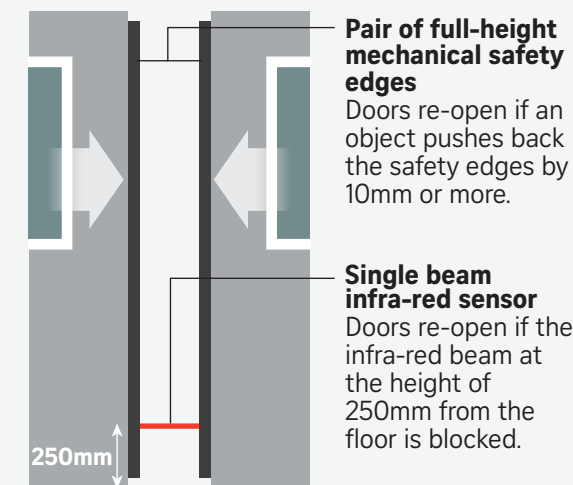
## Safety features of the lift at Block 322

The devices were not designed to detect obstructions that are too thin, such as a 2mm-thick dog leash.
