# Thai rescue mission

## Hazards confronting rescuers

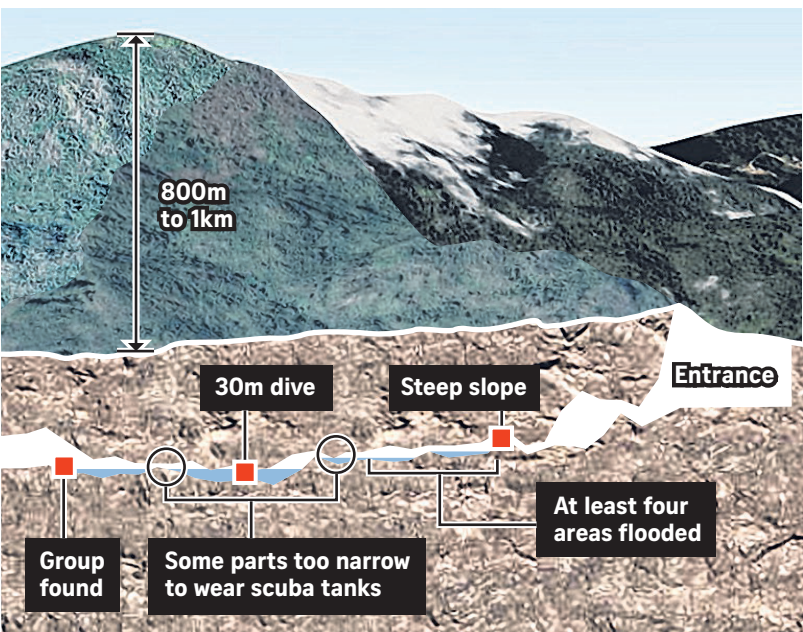
SIDE VIEW OF THAM LUANG CAVE

While some stretches of the cave in Chiang Rai are more than 10m high, others are a tight squeeze for an adult.

NOTE: Artist's impression. Approximate locations. Illustration is not to scale.

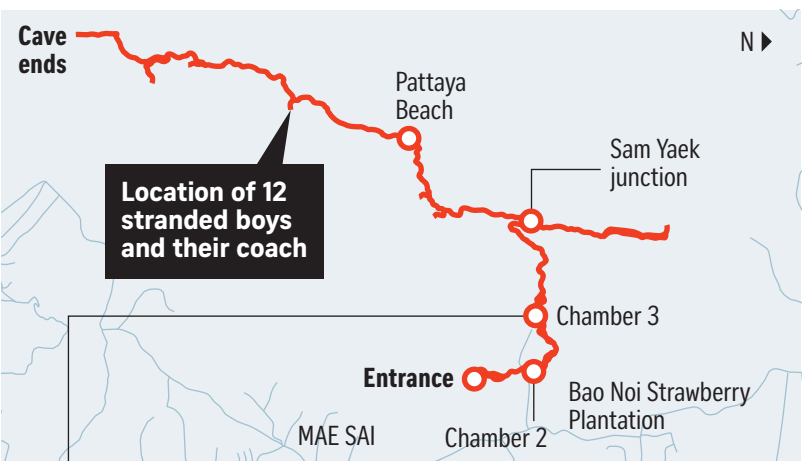
TOP VIEW OF THAM LUANG CAVE

Engineers are draining groundwater and have erected check dams to prevent more rainwater from getting into the cave.

More generators were brought in to drain water from this site yesterday, where Thai Navy Seals have set up base.

- Water is expected to be drained to the point where the stranded boys' heads can be above water.
- Rescuers are also working to drain other parts of the caves leading to the group's location. Draining capacity is at 1.6 million litres of water per hour around the clock.
