# Critical moments before Aloysius Pang was crushed by a howitzer gun barrel

The findings of an independent Committee of Inquiry, delivered in Parliament yesterday, showed that the three soldiers inside the cabin of the Singapore Self-Propelled Howitzer on Jan 19, including the late actor Aloysius Pang, flouted safety protocols, made wrong assumptions and reacted irrationally in the incident that led to the actor's death. Here's how the incident unfolded.

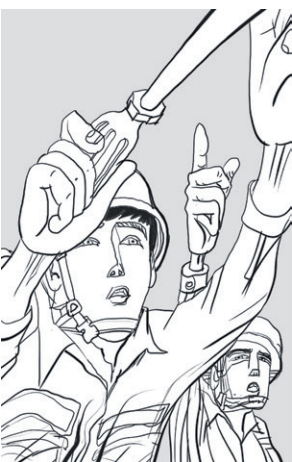
**1** During a live-firing exercise in New Zealand in January, Corporal First Class (NS) Pang, an armament technician on reservist duty, helps a regular technician with maintenance work in the howitzer.

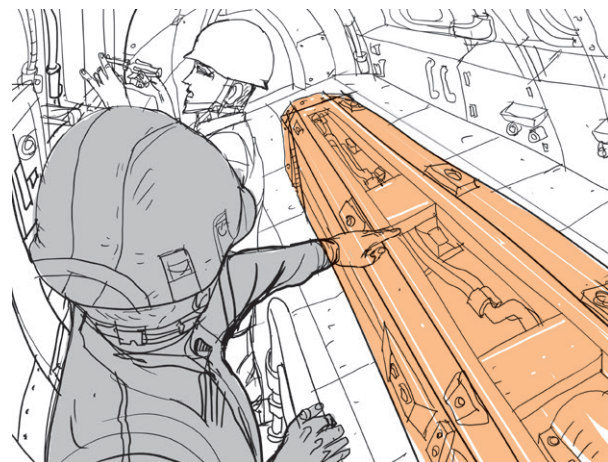
**2** The technician tells CFC Pang in a mix of English and Mandarin to move out of the way for the front of the gun barrel to be lowered to a standby position, which means its rear end will go up.

The actor is not in a designated safe position but replies in Mandarin that it is fine and that the barrel will not hit him.

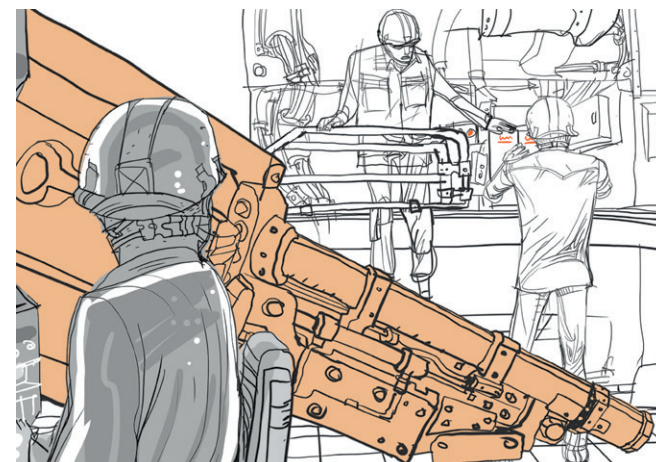
**3** The gun commander checks and sees CFC Pang standing near the end of the barrel, and assumes the actor will have time to move away.

The commander shouts "standby, clear away" and starts lowering the gun.

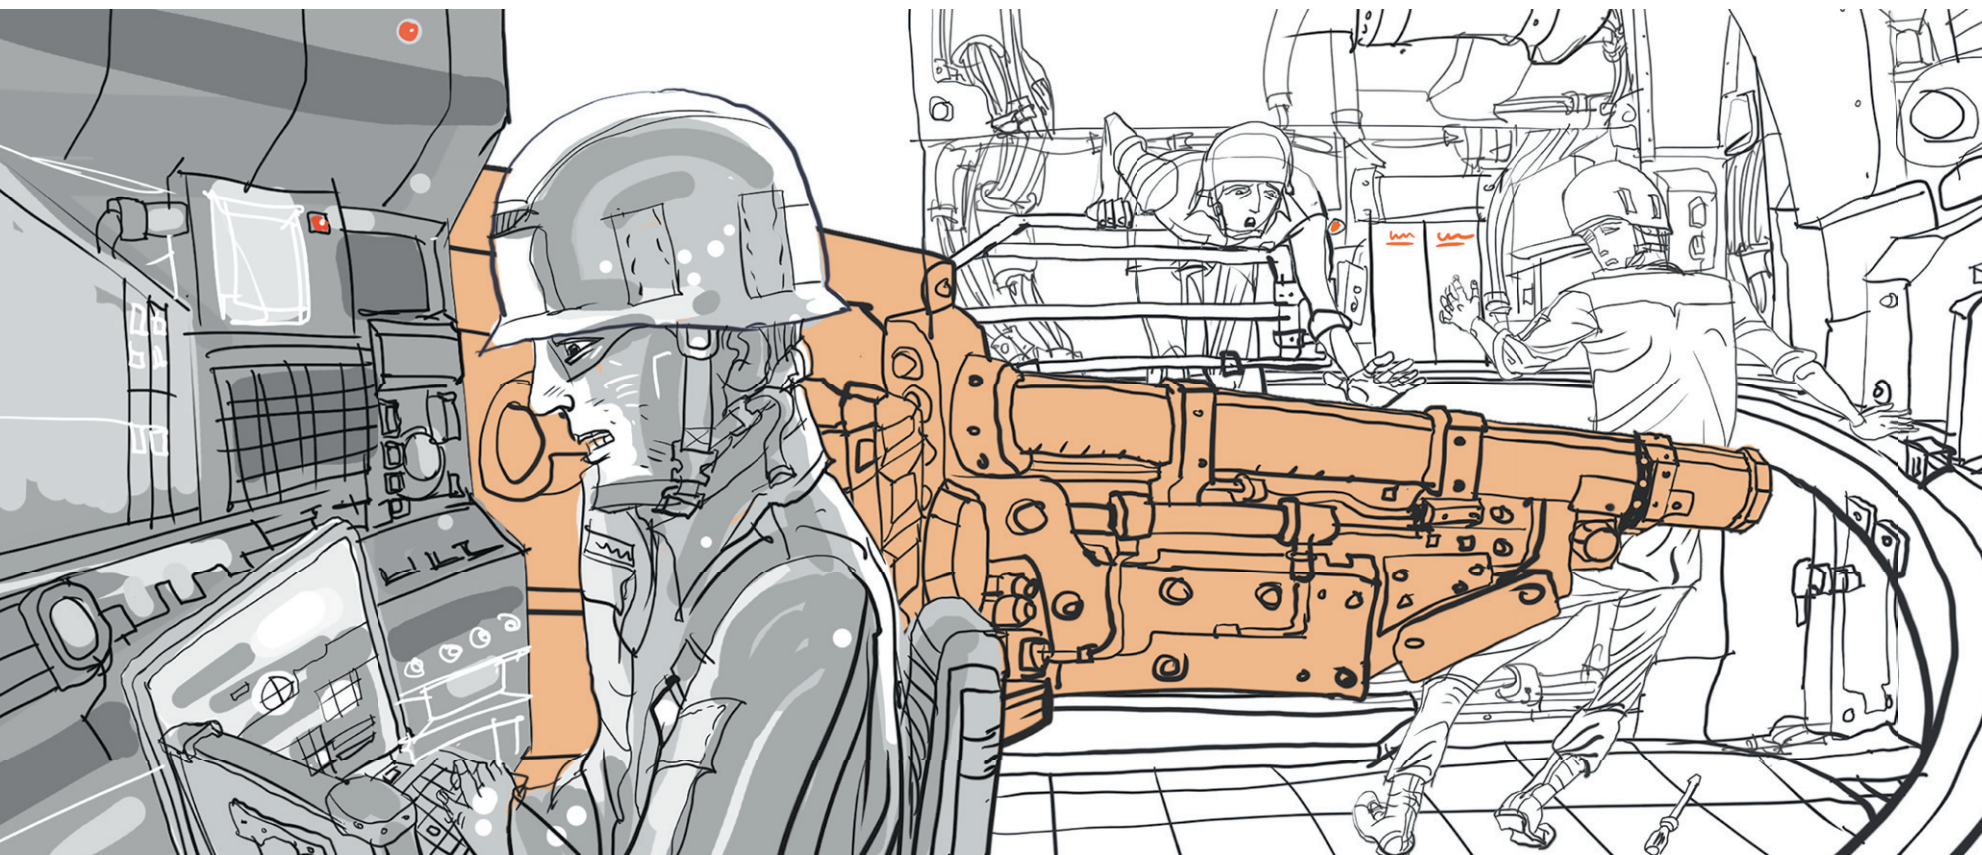
**4** CFC Pang, who has his back facing the barrel, starts taking evasive movements as its end moves closer to him.

The regular technician is in shock and uses his hands to try and stop the barrel, instead of pressing the emergency stop button near him.

Panicking, the gun commander also acts irrationally and uses the main control screen to stop the barrel, instead of using his emergency stop button.

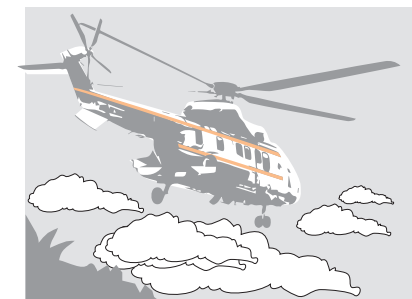
**5** CFC Pang is wedged between the barrel and the interior of the cabin. He is attended to by a medic on site, and later evacuated by helicopter to Waikato Hospital for surgery, where he died from injuries on Jan 23.
