# What caused the 3-line MRT disruption on Oct 14

## CAUSE OF POWER FAILURE

## TIMELINE OF EVENTS

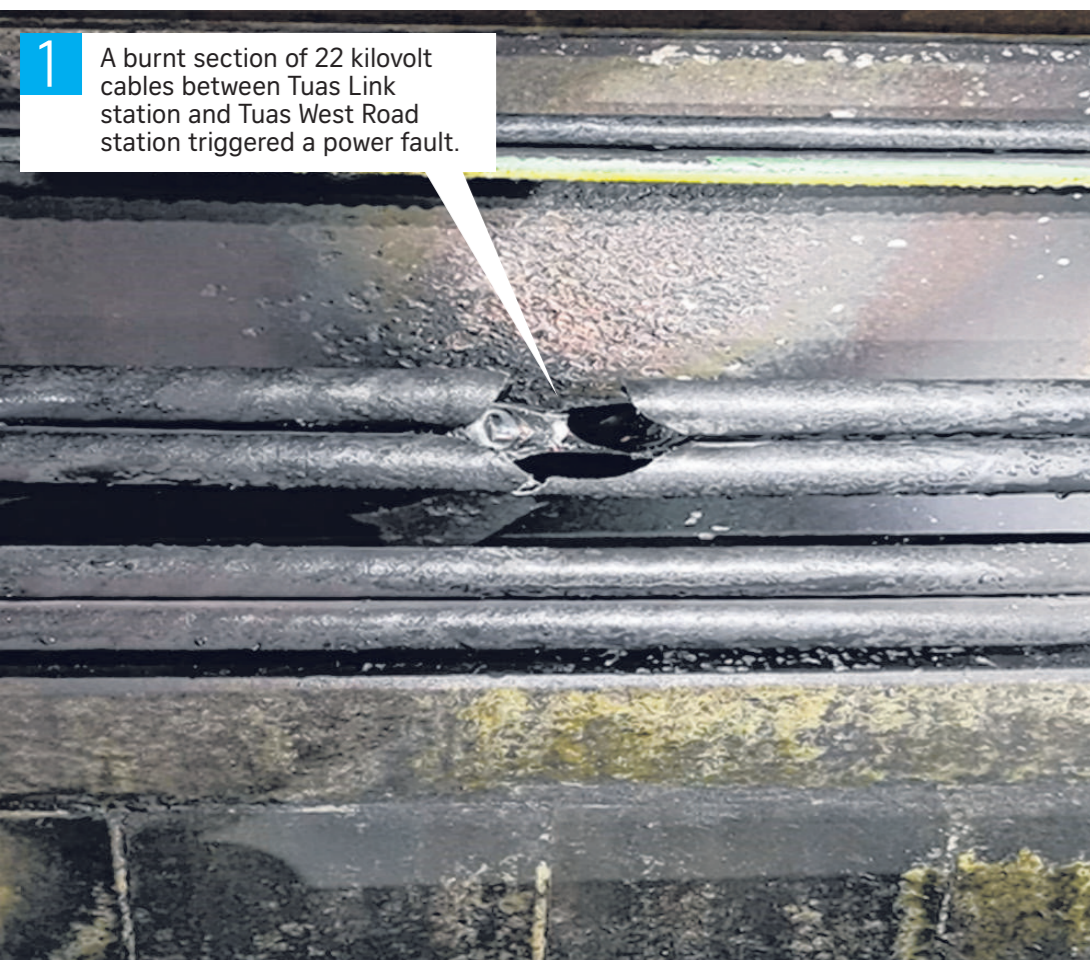
**1** A burnt section of 22 kilovolt cables between Tuas Link station and Tuas West Road station triggered a power fault.

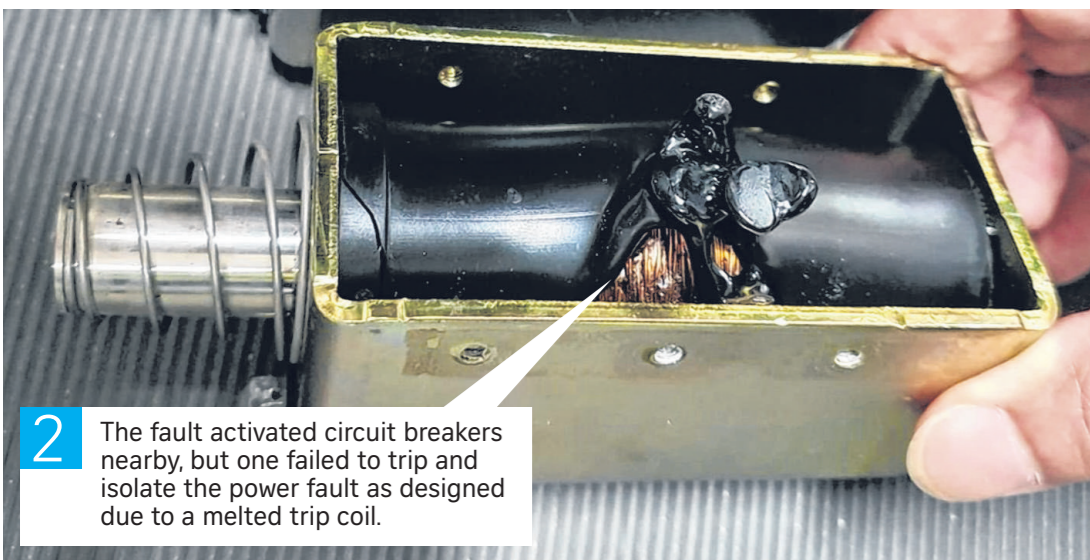
**2** The fault activated circuit breakers nearby, but one failed to trip and isolate the power fault as designed due to a melted trip coil.

- The circuit breaker failure caused a secondary protection system to trip, cutting off power supply from the Tuas Depot substation.
- This affected a larger zone of stations along the North-South and East-West Lines (NSEWL).
