# Three possible reasons for failure of anti-flooding system

Investigations by the Land Transport Authority could not definitively establish what led to the Oct 7 flooding incident, though the LTA said it was down to "a lack of proper maintenance, supervision and audits".

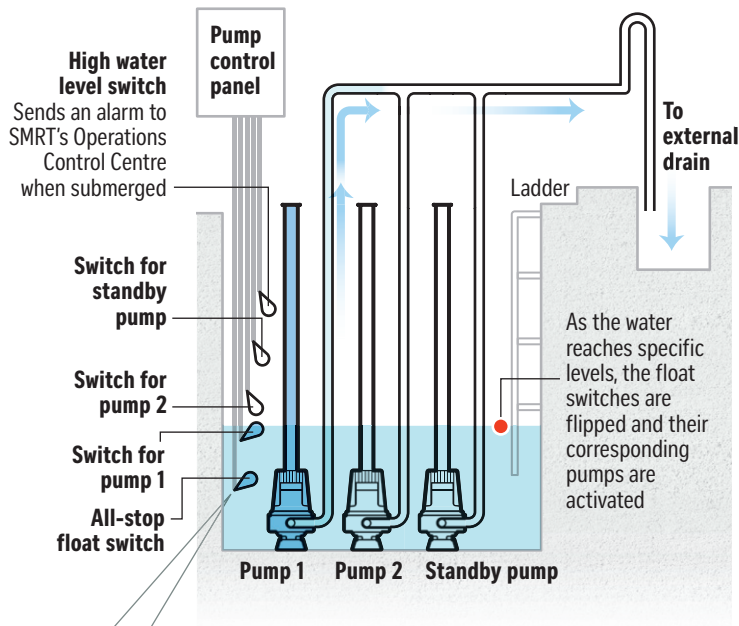
## THE STORM WATER PUMP SYSTEM

**1** The lowest float switch, which would have activated the storm water sump pumps, was impeded by accumulated silt and sludge in the Bishan storm water sump pit.

**2** Floating debris in the pit could have impeded the normal functioning of the float switches, in particular the highest float switch, which alerts SMRT's Operations Control Centre to high water levels.

**3** An SMRT maintenance team which conducted corrective work on the pump system on July 13 could also have left the pump controls in manual mode after their work was done.

- 1** All existing float switches at Bishan storm water sump pump pit replaced by SMRT
- 2** LTA replaced Bishan pumps with heavier-duty ones capable of handling water with sediment
- 3** New radar-based sensor system added to monitor water levels in the pit
- 4** New sump pump control panel installed, located away from tracks to facilitate access during passenger service hours
- 5** Accumulated sludge, silt and debris removed from pit. All non-serviceable pumps on the North-South and East-West lines replaced, with float switches replaced as a precaution
